Laytonsville Fall Update Community Meeting

Thursday, November 9, 2023

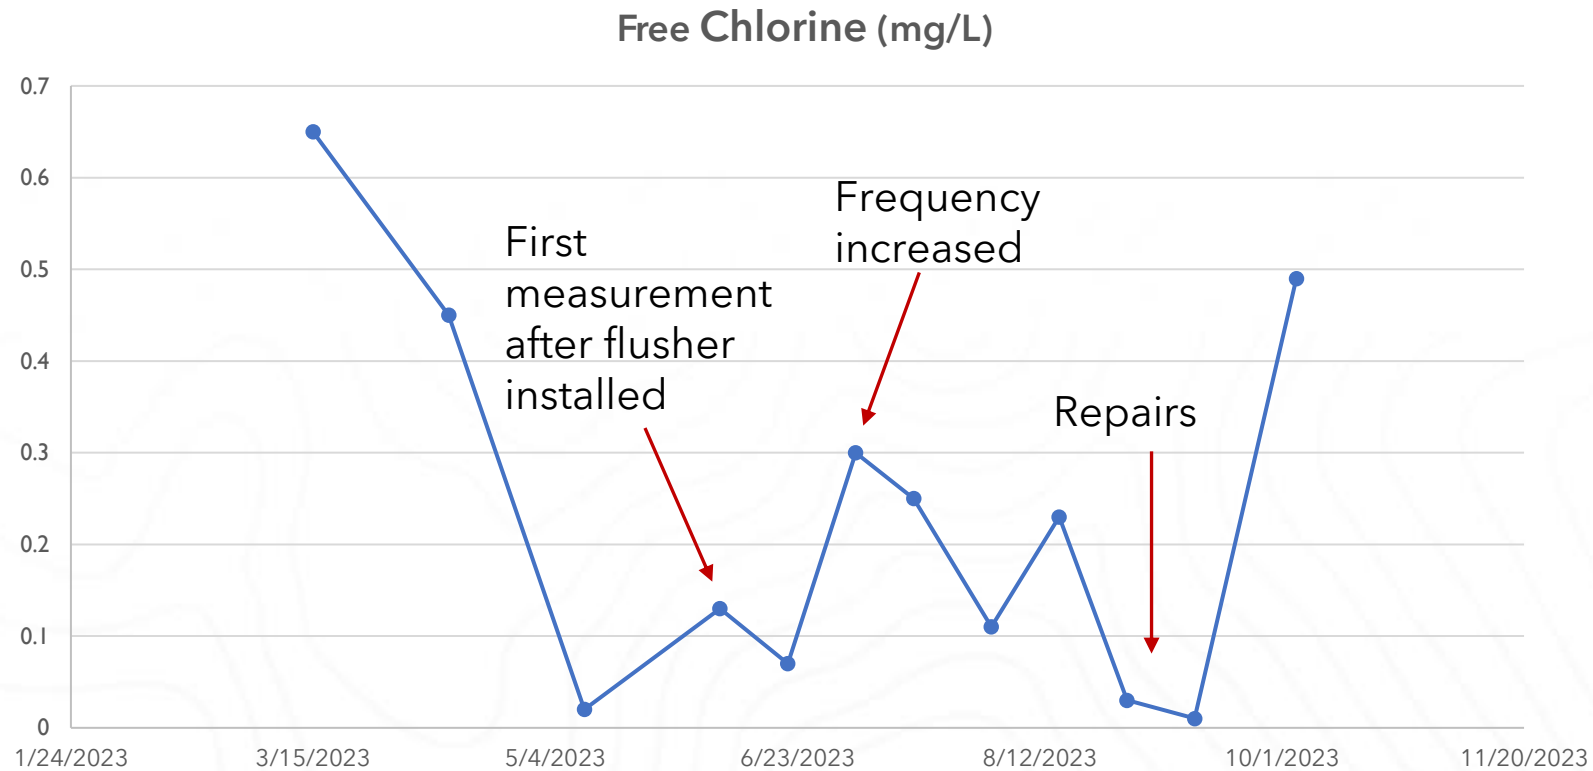
- Automatic flusher is effective

- Modified water flow
- Installation of automatic flusher on Birdie Lane
- Monitored hydrants for chlorine and bacteria
- Conducted biweekly chlorine checks (June - August)
- Chlorine tests will continue through winter
