**TOWN OF LAYTONSVILLE
HISTORIC DISTRICT COMMISSION**

**HISTORIC DISTRICT WORK PERMIT
APPLICATION**

SUBJECT PROPERTY ADDRESS: 7101 Brink Rd, Laytonsville
Lot _____ Block _____ Subdivision _____

Introduction – R & R of Old Barn at 7101 Brink Rd

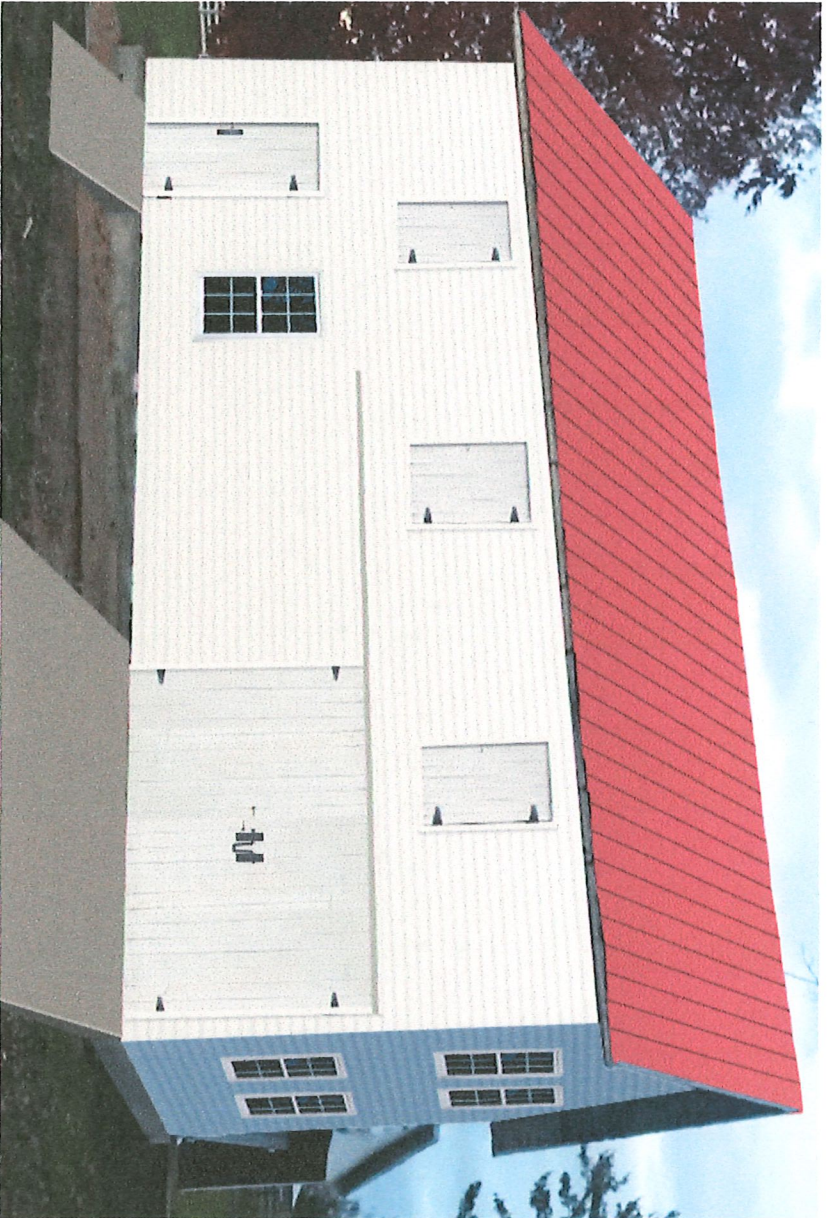
Illustrated Front View of Old Barn After Repair and Replacement Activities

- With old barn building stabilized, continue repair and replacement activities on external structures
 - Eliminated concern about potential collapsing in a 2024 Winter storm
- Remove & replace roof with red metal material (approved 1/15/2024)
- Install new equivalent German siding on all sides of old barn – paint white
- Replace two entrance doors and seven windows
- Replace large front entrance doors with a single large sliding door mounted on a track similar to others in the Laytonville area
- Repair and fill-in concrete apron at front of barn for improved access of farm equipment, animals, and humans
- Paint, repair, and add new metal gate in wooden fence (approved 1/15/2024)
- There are no building additions to the barn. The physical footprint of the barn remains the same.

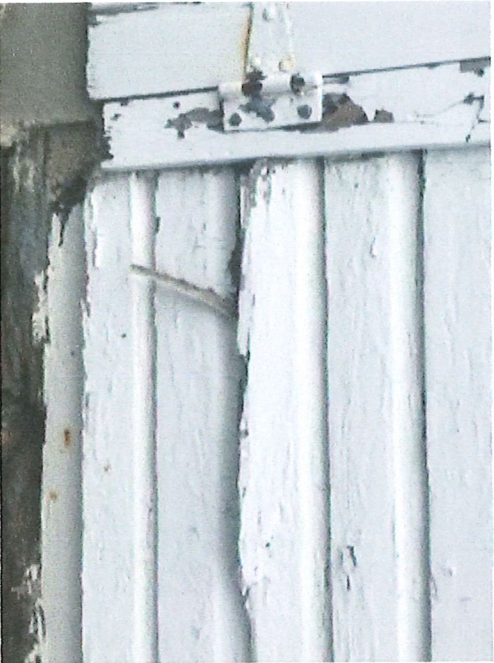
Original rotting German siding at bottom and up the walls. This includes damage from rain and other moisture.

- Remove and replace all rotting and deteriorating German siding on all four sides of the old barn
- Architectural change of all repair and replacement work visible from Brink Road primarily the front of the old barn (South Side)
 - Paint all the German siding white as the current color
 - Results will look exactly like the current siding
- **Quantity required (estimated) – 4400 linear feet**
 - Currently milled and waiting for delivery since 30 Nov
- **Source: Hicksville Planing Mill, Clear Springs, MD**

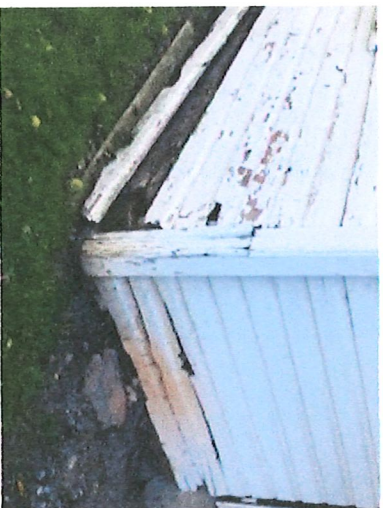
Attempts to reattach bottom board with nails or screws resulted in siding disintegrating with each turn of the screwdriver or pounding of the hammer

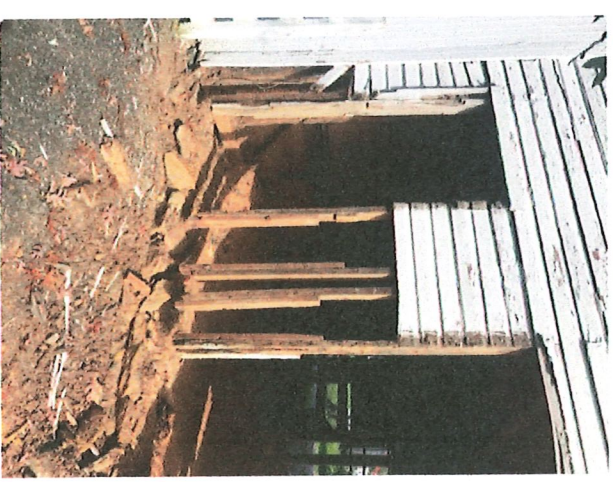
Dry rot on siding further up the wall. Note rotted beams not even touching the ground.

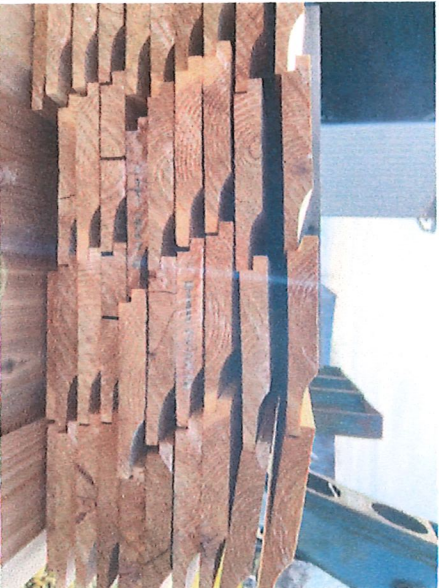
Side view of interlocking German siding from the Hicksville Planing Mill.

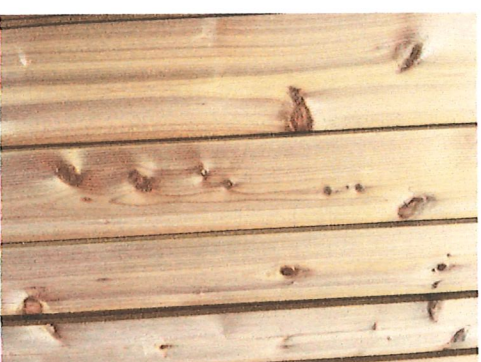
Longitudinal view of the German siding

For repair and replacement, contractor will paint all German siding white.

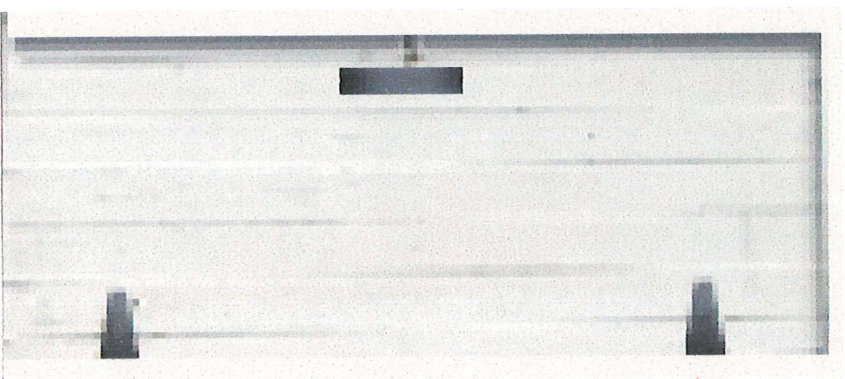
Wood entrance doors to be constructed from repurposed wood saved during the project. Outer wooden door covers the metal inside door.

Some repair or replacement needed given the condition of the wood and size of entrance door.

Black hinges and latches added to doors to add some contrast to the all-white German siding.

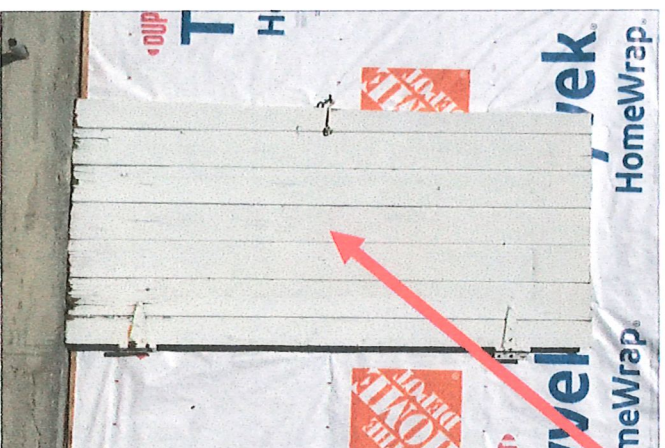
Wooden outer door added to hide metal door. HDC and Mayor informed of temporary installation on 2 Feb 24 for pictures for permit application.

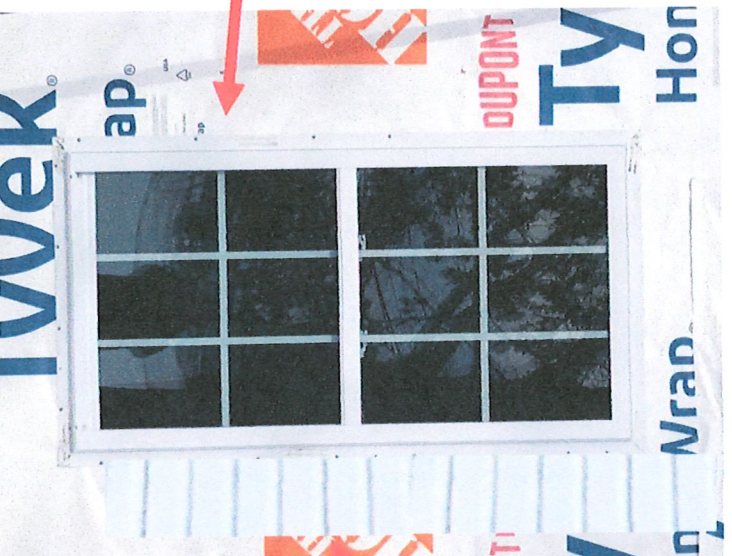
Construct framing around all four sides of windows from repurposed wood saved during the project. Wooden frame surrounds the edges of the vinyl simulating a wooden window.

Some repair or replacement of the wood needed given the overall condition of the materials.

Small sample of German siding painted white for installation on all four sides of the barn.

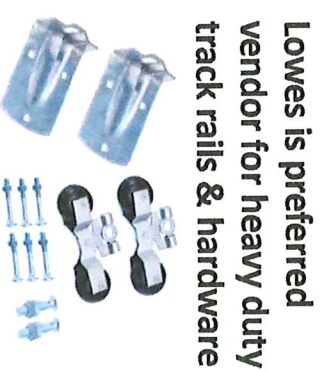
To simulate swinging doors, added latches/handles and hinges

Wood doors to be constructed from repurposed wood saved during the project.
Some repair or replacement needed given the condition of the wood and sizes of doors.

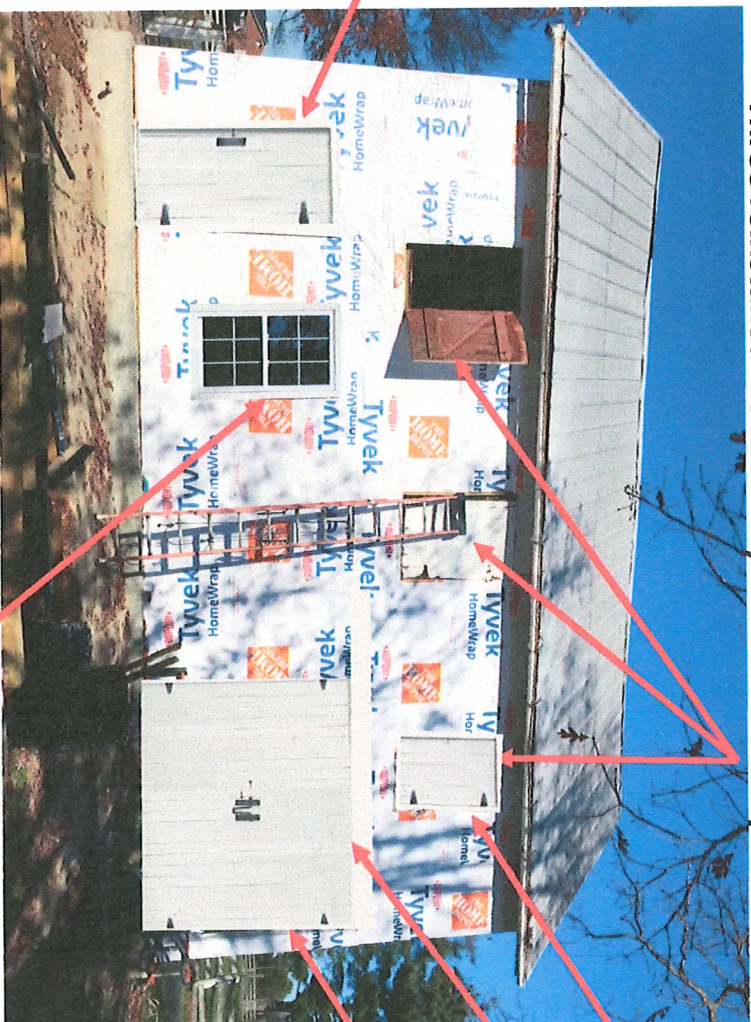
Barn View – Front Side - Revised

Three reinstalled wooden hayloft doors that open into 2nd floor

Wooden outer door covering metal inner door

Note: all wood surfaces including German siding painted in white color

Sample frame around hayloft door

Wooden valance covers sliding door track

Double wooden door on sliding track. Black hardware (hinges & latch) added to look like swinging doors. Black hardware adds contrast to the all-white German siding to be installed.

Door slides to the left

Wooden frame around vinyl window

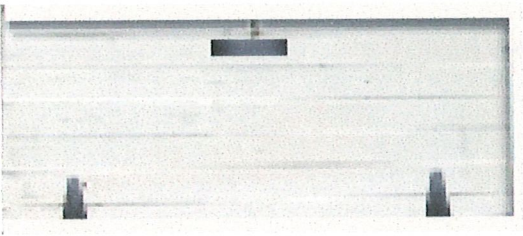
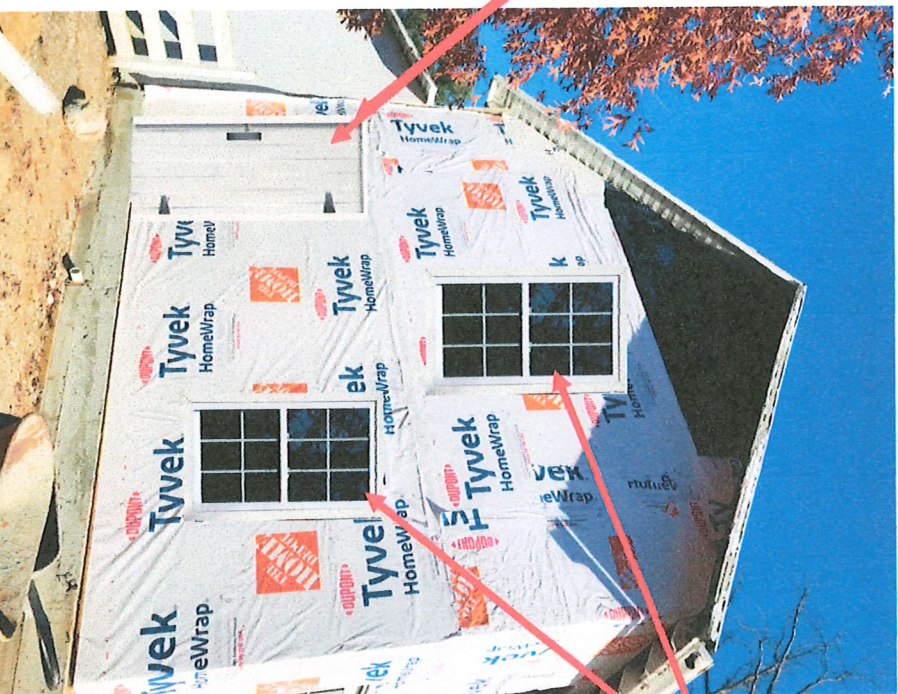
Barn View – West Side

Wooden outer door covering metal inner door

Wood entrance doors to be constructed from repurposed wood saved during the project

Vinyl replacement windows added constructed from repurposed wood saved during the project

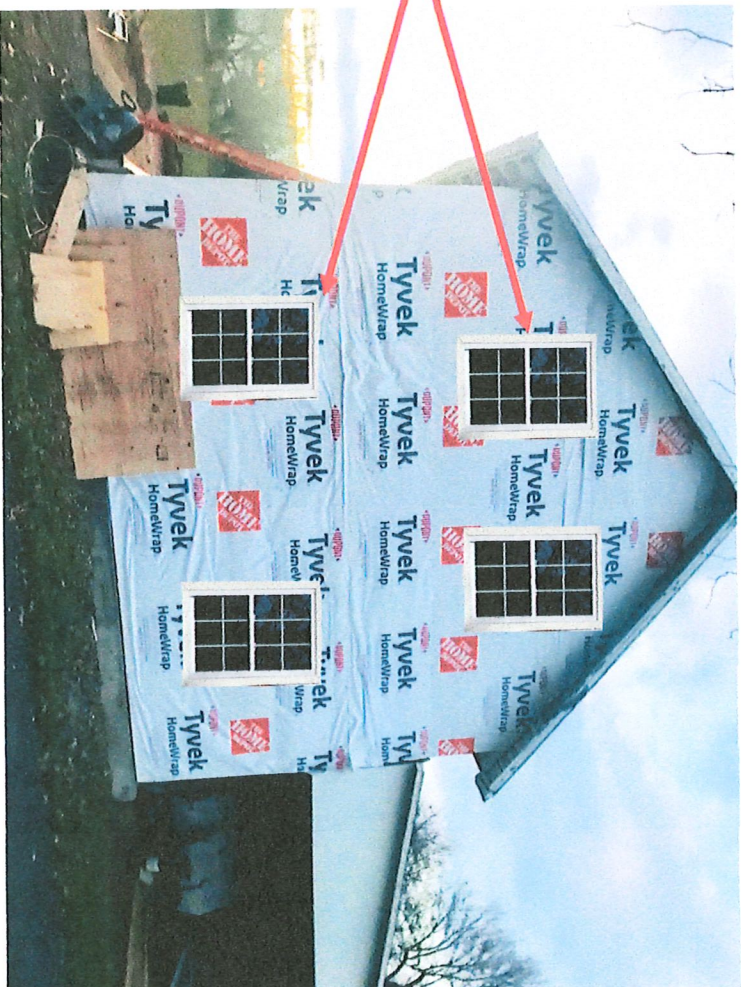
Barn View – East Side

Vinyl replacement windows with white wooden frames added using repurposed wood saved from the project.

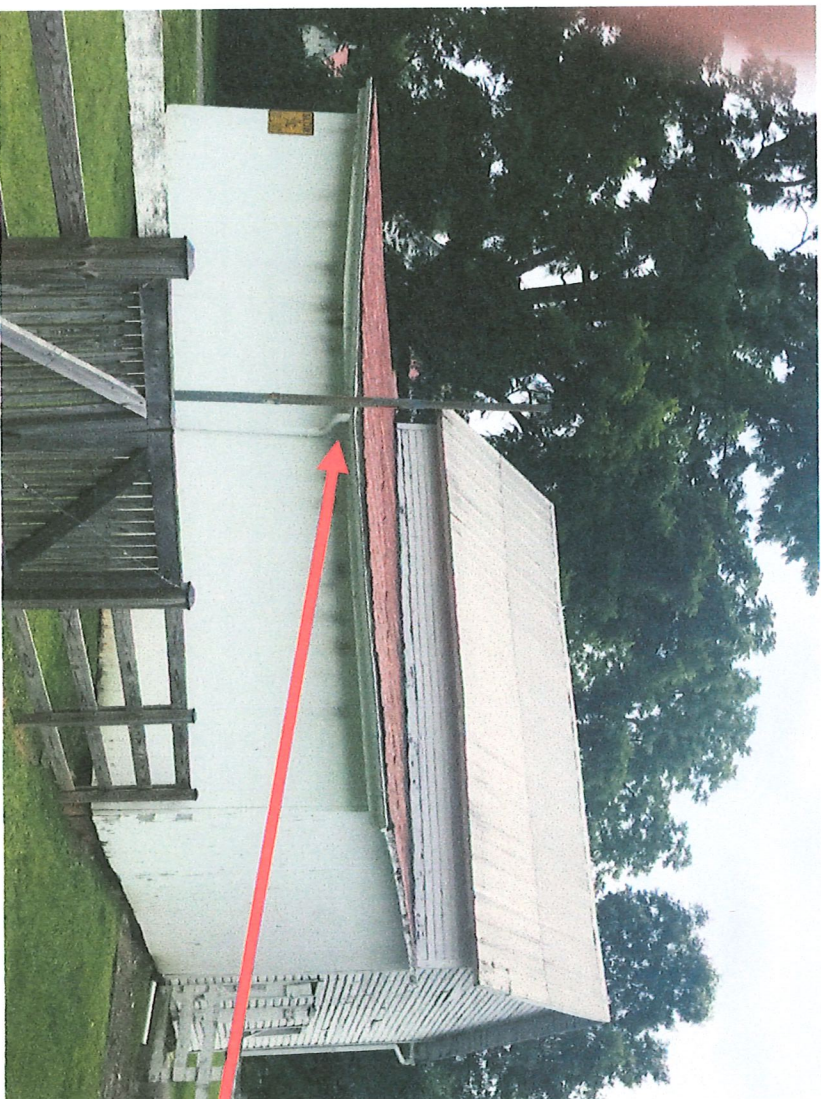
Barn View – North Side (rear)

There are no windows or doors at the rear of the barn.

Note: Rear of barn is not visible from Brink Road

Sagging red roof caused by cracked internal beams that need repair as roof & German siding installation proceeds.

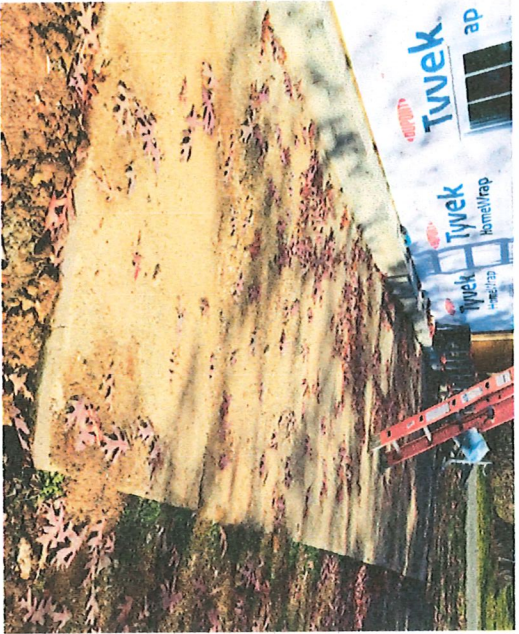
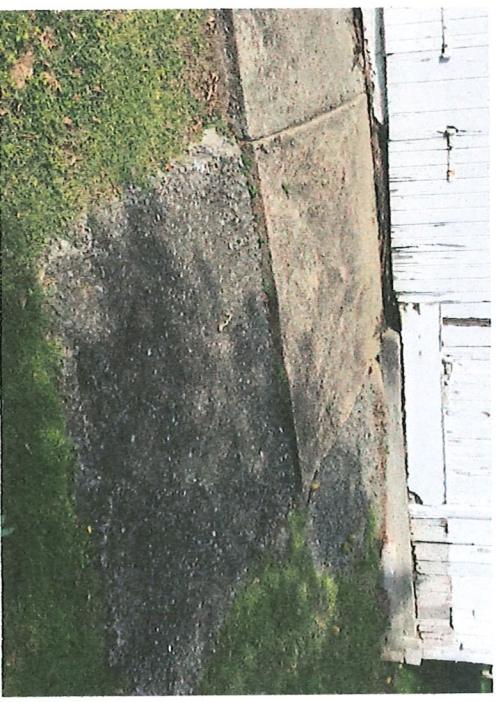
Concrete Apron

Random chunks of concrete plopped in front of barn making it difficult to drive farm equipment, animals, or people in and out of the old barn.

- Irregularly shaped concrete slabs with gaps between them are located randomly in front of the barn. The uneven pattern and changing levels along with the spaces make this hazardous.
- Concrete slabs are not visible from Brink Rd.
- Repair and fill-in concrete apron at front of barn for improved access of farm equipment, animals, and humans
- Source: Local concrete company - MFI Concrete, Woodbine, MD

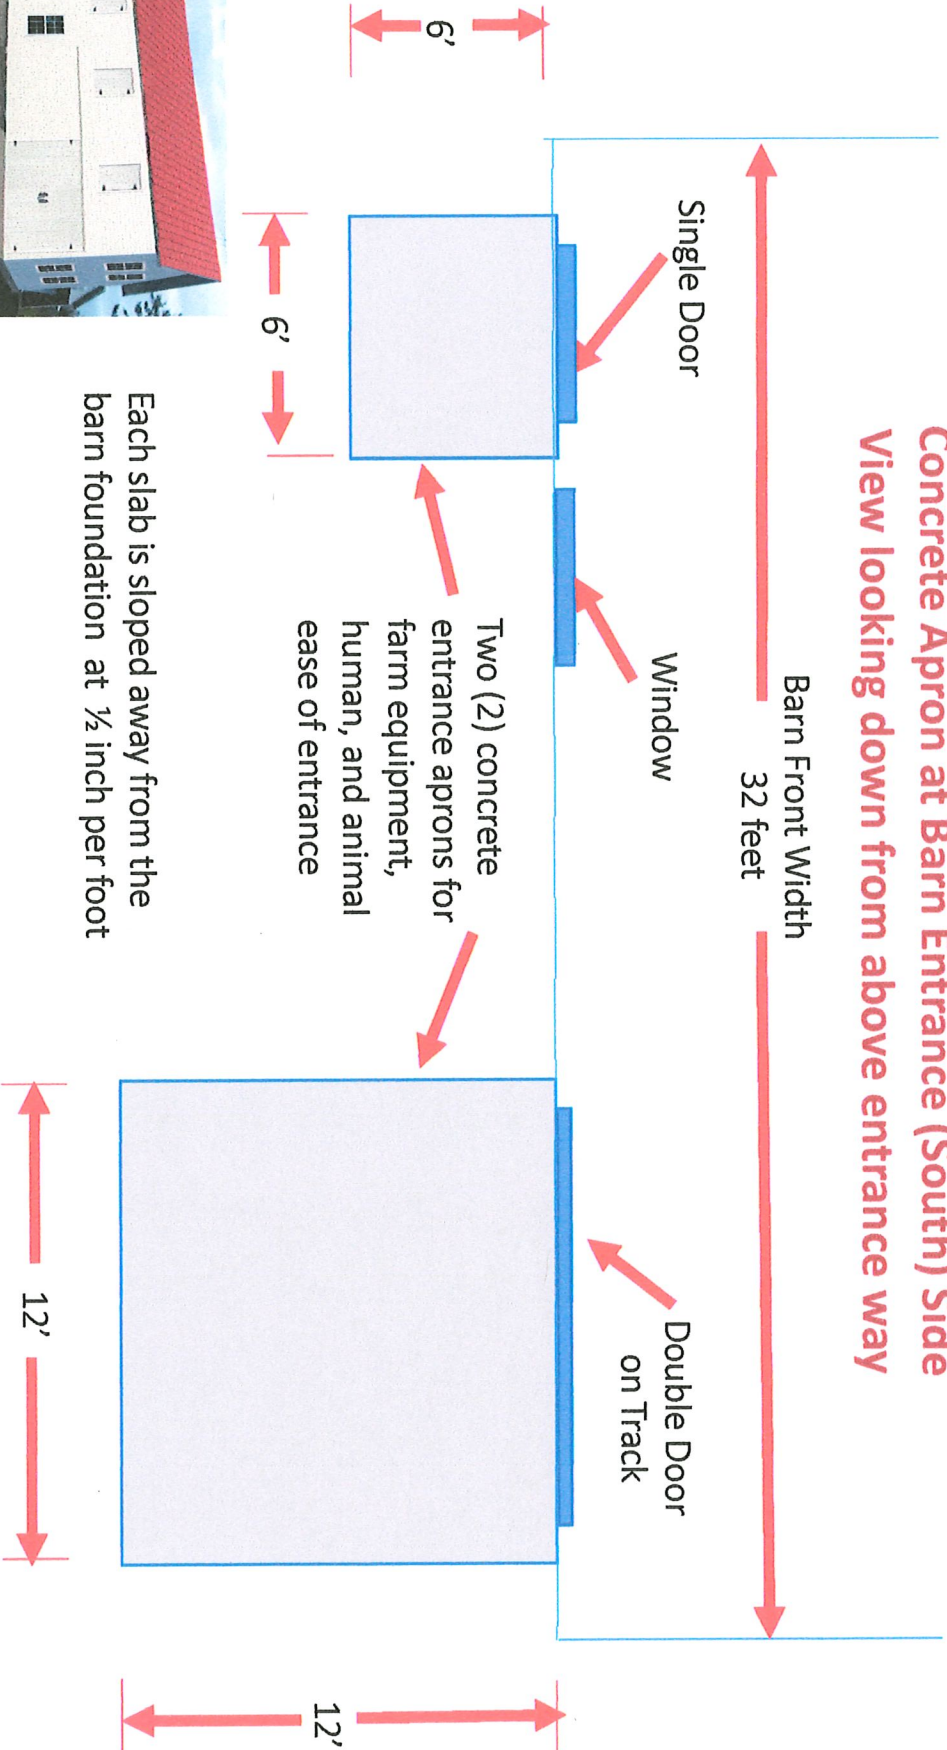
Concrete Apron at Barn Entrance (South) Side View looking down from above entrance way

Two (2) concrete entrance aprons for farm equipment, human, and animal ease of entrance

Each slab is sloped away from the barn foundation at 1/2 inch per foot

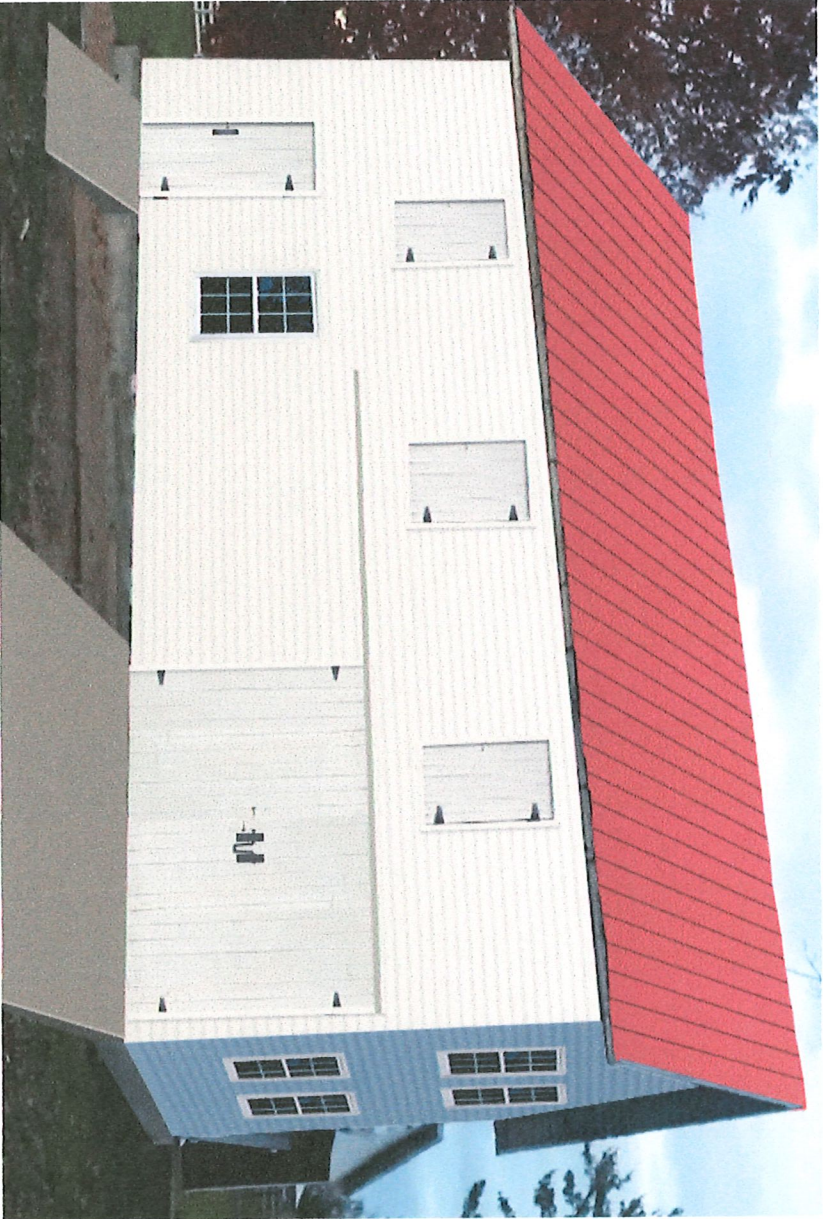
Illustrated Front View of Old Barn After Repair and Replacement Activities

The following two activities

(1) Remove and Replace Metal Roof, and

Remove and Replace Metal Roof (Approved)

- Current roof leaks around the ridgepole & has many small holes or gaps along with buckling of the panels resulting in leakage.
 - Roof and gutters need replacement or repair.
 - Remove current metal roof
 - Assess & repair supporting roof structure
 - Replace metal roof with new red metal panels
 - Repair or replace gutters and downspouts
- Source of metal roof replacement materials:
 - Marco Metals LLC of Virginia
- Architectural change visible from the road: change of color from bare metal to red consistent with other nearby structures

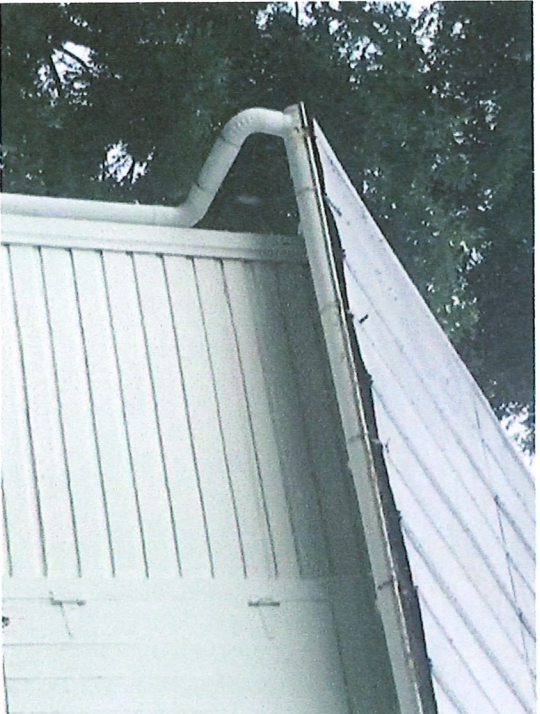
Metal Roof Deterioration

Current pictures of deteriorating neutral colored metal roof panels showing buckling of panels, gaps between sections of long panels, and structural distortion of the metal panels along the ridgepole.
